Texas Hospital Complex Solves its Air Conditioning Problems With ENECON CeramAlloy

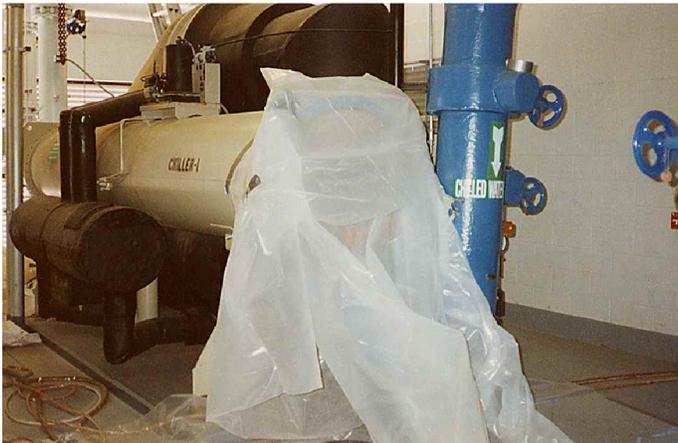
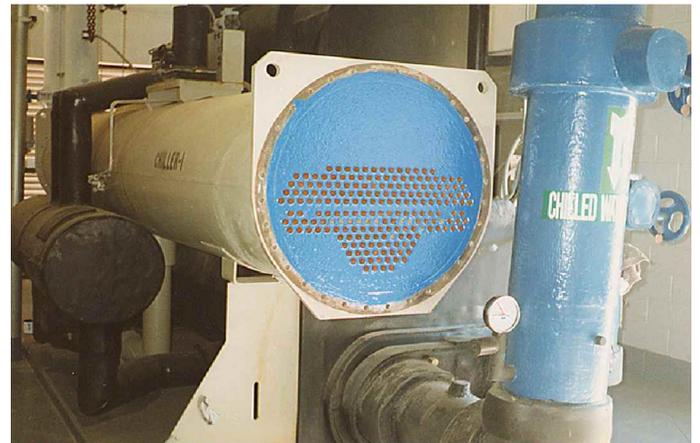
Erosion and Corrosion damage was evident on the chillers of their

air conditioning system and they wanted the best material to repair the damage and provide long-term protection from future damage.

The ENECON engineer suggested the cost

effective solution...CeramAlloy CP+ and CL+ to rebuild any damaged metal and then resurface the end covers as well as the tube sheets on the chiller.
