## DuraQuartz & CHEMCLAD Used to Repair Tile Floor at Pennsylvania Hospital Kitchen

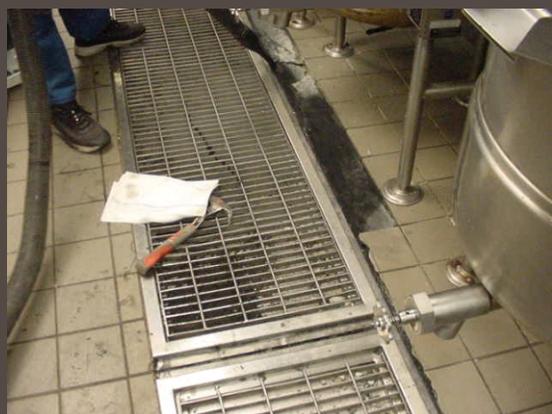
Some tiles were in such poor shape that they were completely removed.
