New York City Wastewater Treatment Plant Turns to ENECON for Critical Pipe Repairs

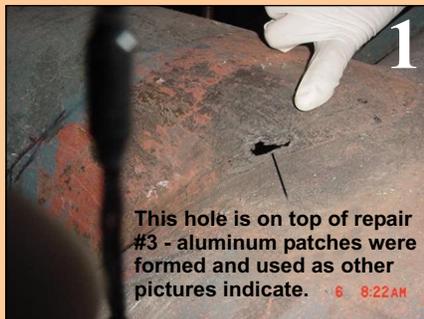
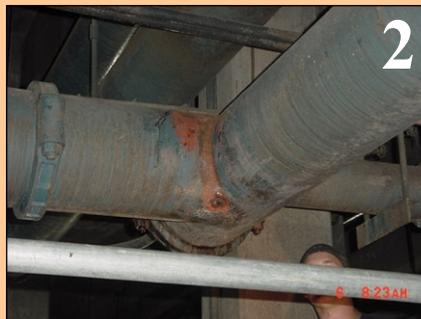
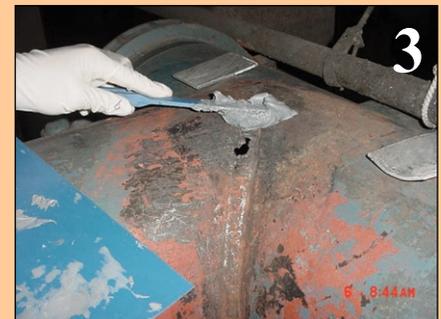
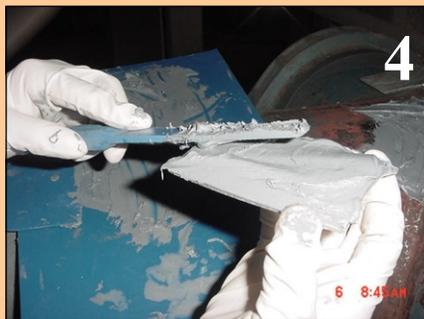
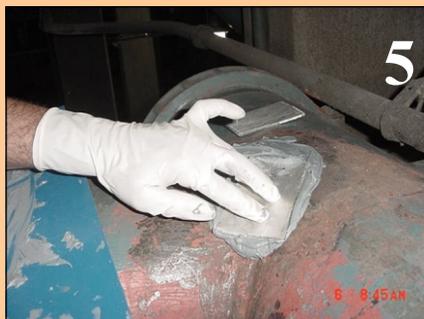
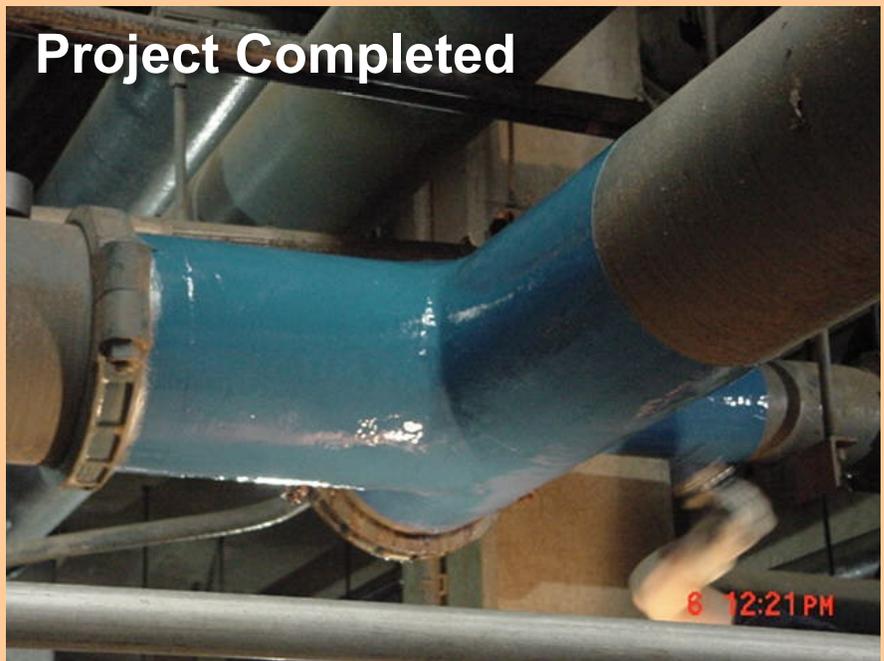
Two coats of CeramAlloy CL + AC were then utilized to complete this pipe-wrap procedure.
